# STUDYING X-RAY SPECTRA OF THE SIS18 ELECTROSTATIC SEPTA TO MEASURE THEIR ELECTRIC FIELD

B. Gålnander<sup>†</sup>, E. Kozlova, D. Ondreka, A. Sokolov, P. J. Spiller, J. Stadlmann  
GSI Helmholtzzentrum für Schwerionenforschung GmbH, Darmstadt, Germany

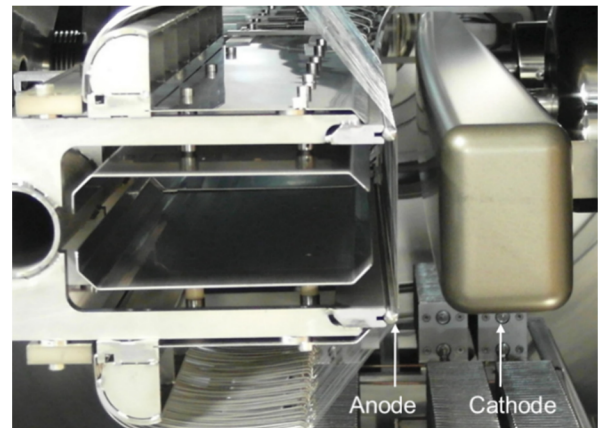
Figure 1: The electrostatic extraction septum in the beam direction with the anode wires and the cathode pointed out. The circulating beam area is to the left, and the extraction channel is to the right between the anode wires and the cathode.

At the SIS18 synchrotron, at GSI, there are two electrostatic septa, one for injection and one for slow extraction, see Fig. 1. Both septa are of similar design, but are used with a different electrode distance and voltage [1]. The extraction septum at present has an 18 mm electrode gap and the injection septum a 35 mm gap. The electrostatic extraction septum is designed for a deflection angle of 2.5 mrad, which for particles with the maximum electric rigidity, 5.3 GV, is obtained at an electric field of 90 kV/cm. See Table 1 for a summary of the septa parameters.

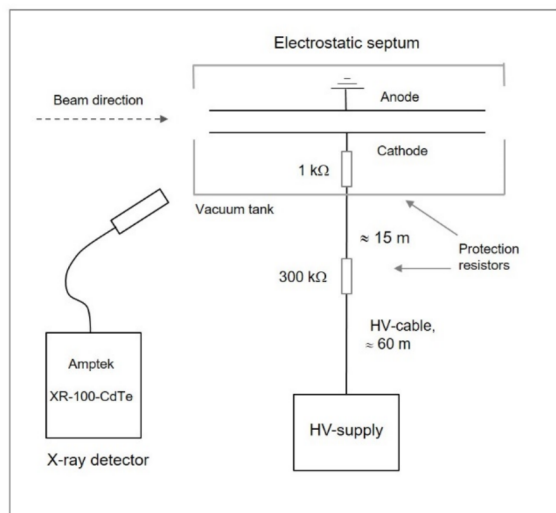
The measurements were performed with the detector at the upstream flange of the electrostatic septum tank, where lower background due to activation is expected than at the downstream flange. The measurement set-up is shown schematically in Fig. 2, including the HV-supply and the protection resistors for dissipating the energy stored in the cable in case of discharges.

Figure 2: Schematic measurement set-up, with the X-ray detector at the upstream flange of the electrostatic septum.

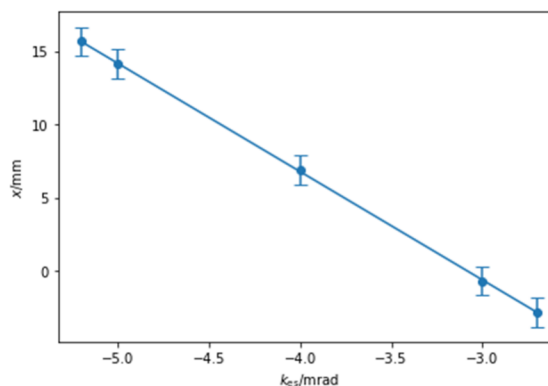
In this section we briefly present beam studies performed recently in order to quantify the deflection angle of the ES. In SIS18 the ES is situated in sector 4 and the magnetic extraction septum in sector 6, after about 240 degrees phase advance, and there is no diagnostics to directly measure the deflection of the electrostatic septum in the ring. Instead the beam position was measured at a viewing screen in the extraction channel after the magnetic septum. The voltage of the ES was changed in terms of the nominal, theoretically expected, deflection angle and the position at the screen observed, see Fig. 3. The expected value is 13 mm/mrad, and the measurements show a position change at the viewing screen of 7.4 mm/mrad, only about 55% of the expected value.

Figure 3: Deflection of beam by changing nominal extraction septum angle, as observed by beam position at a viewing screen after the magnetic extraction septum.

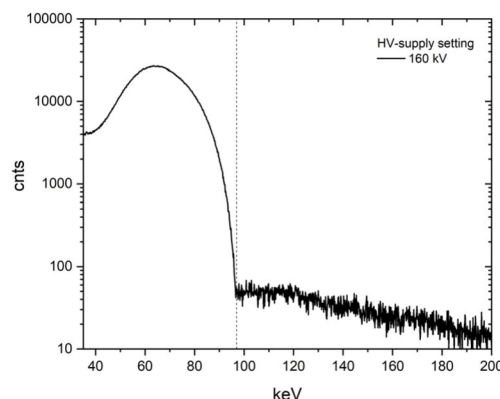
In this section the results of the X-ray measurements are summarised. Figure 4 shows the first measurement at the extraction septum for a setting of -160 kV of the HV-supply. As can be seen the high energy cut-off of the X-ray spectrum was about 98 keV, instead of the expected 160 keV. Figure 5 displays the spectrum at the injection septum, as a comparison. Here, the high energy cut-off was at 205 keV, well in correspondence with the HV-supply setting of -205 kV.

Figure 4: X-ray spectrum for the first measurement at the extraction septum. High-energy cut-off at about 98 keV.

After the X-ray measurements, control measurements with a voltage probe off-line, revealed that the HV-supply for the extraction septum was defective and the supply was replaced. The measurements were repeated and it could be confirmed that the X-ray cut-off energy corresponded to the HV-supply voltage setting within 5%, see Fig. 6. A difference of 8 keV is observed, which will be investigated during the next beam shutdown period. The results of the X-ray measurements are summarised in Table 2. The table also shows the currents from the HV-supply and corresponding equivalent dose-rates at about 0.5 m distance from the upstream flange.

After the X-ray measurements indicated the problem, the error could be detected, and solved by replacing the defective high-voltage supply. Repeated X-ray measurements confirmed that the voltage of the ES was correct (within 5%, the discrepancy will be further investigated). It is not clear at the time of writing how long the HV-supply has been giving the incorrect voltage. The fact that the HV-supply of the extraction ES had already been fully replaced once during the lifetime of SIS18 led to the erroneous assumption that the HV-supply was not the problem, which triggered an extensive but ultimately unsuccessful investigation to find a possible other cause. With the new HV-supply, the extraction septum works correctly, resulting in significantly lower losses at the magnetic septum for nominal settings than before.

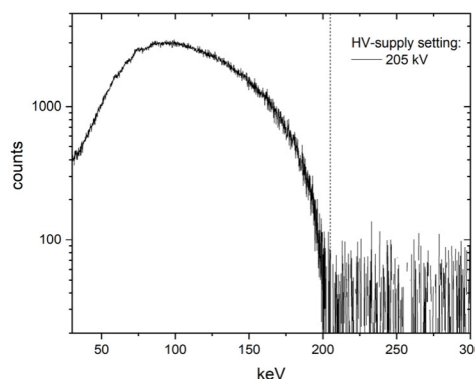
Figure 5: X-ray spectrum at the injection septum. The high-energy cut-off corresponds to the voltage setting.

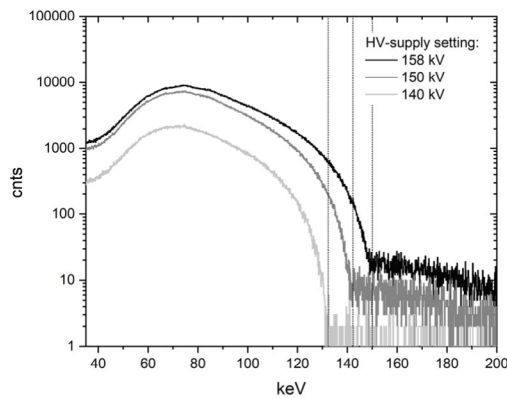
Figure 6: X-ray spectrum with new HV-supply, three different voltage settings.
