## Quality assurance for large-scale GEM-foils\*

A large scale GEM-based tracker has been designed [1] as a forward particle-track detector for the PANDA experiments. The detector system consists of three GEM-Discs, each working as a large-area planar GEM detector. The size of GEM-foils is three orders of magnitudes larger than the 'standard' one ( $10 \times 10 \text{cm}^2$ ), therefore a fast and automated quality assurance method has to be established.

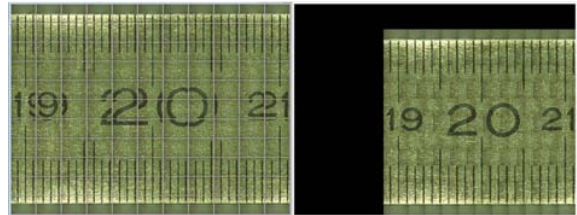
Figure 1: An example of an automated scan showing 121 consecutive images of a scale with 2mm pitch, unstitched (left) and successfully joined (right).

A control software of the 2D-scanning system has been made using LabVIEW to perform an automated image taking. Figure 1 demonstrates the scan results for a scale. The scanning reproducibility has been measured using a microscope (VHX-600 KEYENCE) by comparing images of the same scan position for different runs using an pattern matching algorithm. In order to inspect micro scale structure of GEM foils (fig.2 top), an analysis program has been developed detecting pre-definable objects e.g. contours of GEM holes (fig.2 bottom). The diameters which have been fitted with circles and resulting in parameters such as location of the respective centers and deviation from the ideal circle are plotted and stored in a file.

The scanning reproducibility has been deduced to be  $(1.7 \pm 1.1) \mu\text{m}$  for the test performed on a stone table in the clean room of the GSI detector laboratory. The 2D-stage and microscope head will be mounted on a dedicated supporting structure in spring 2014 to be constructed as the complete scanning system. Similar reproducibility tests are foreseen after the assembly.

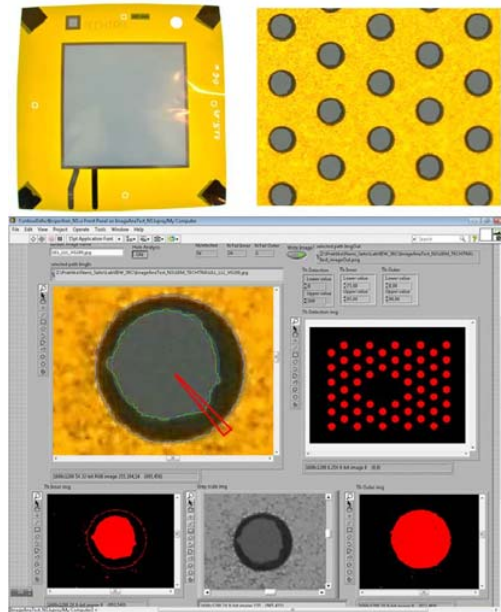
Figure 2: A sample GEM foil (top left) and a zoomed view (top right). GUI of the image analysis program (bottom). An example of analyzed contours and circular fit of an inner hole in the base material and an outer rim in the copper cladding of a GEM hole are shown. A large deviation from the ideal circle is detected and marked by a triangle.

Image analysis has been performed for 5 samples of standard GEM-foils with various optical settings to find an optimum setting for an appropriate image analysis. Currently, the analysis process is sensitive to the image quality and time consuming. Appropriate algorithms to speed up the whole processing as well as improvements on the hardware are under investigation.
